**BOARD OF PILOT COMMISSIONERS FOR THE  
BAYS OF  
SAN FRANCISCO, SAN PABLO, AND SUISUN**

**INCIDENT REVIEW COMMITTEE  
INVESTIGATION REPORT**

**REPORT OF THE INTERACTION BETWEEN THE M/V HYUNDAI NEPTUNE  
AND THE M/V THALASSA AVRA WHILE PASSING BERTH #37, AT THE PORT  
OF OAKLAND, ON MAY 21, 2020  
PILOT: CAPTAIN DREW AUNE**

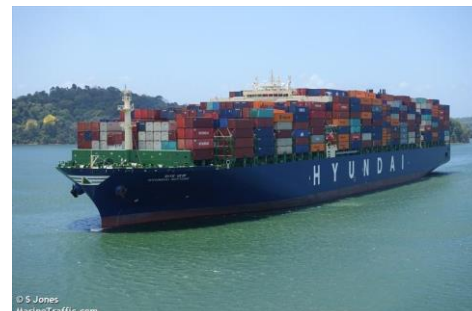
Vessel Particulars:

Length: 1014 feet    Beam: 157 feet  
 Average Draft: 42 feet deep  
 Tonnage: 110,632 gross tons  
 Propulsion: Diesel Engine  
 Owner: Zodiac Maritime  
 Operator: HMM Co., Ltd. (Hyundai Merchant Marine)

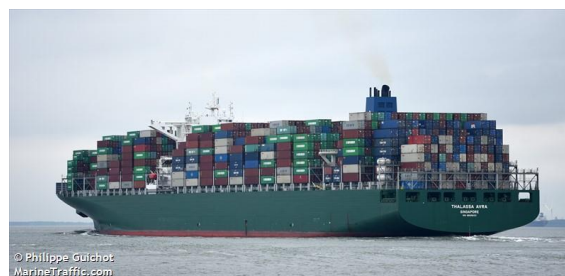
THALASSA AVRA is a container ship registered in Singapore. She was built in 2014.

Vessel Particulars:

Length: 1209 feet    Beam: 167  
 Average Draft: 46 feet deep  
 Tonnage: 148667 gross tons  
 Propulsion: Diesel Engine  
 Owner: Thalassa Avra PTE Ltd., Athens, Greece  
 Operator: Enesel PTE Ltd., Athens, Greece
